APEX RESTORATION CO.

DAILY DRYING REPORT

Job #JOB-2024-0847 | March 23, 2026 | Day 3 of 5

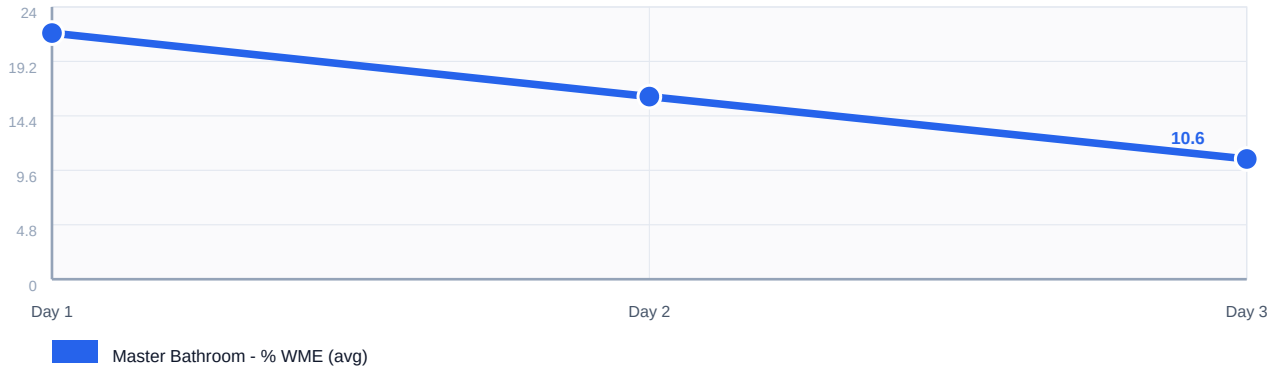
Master Bathroom

Location	Material	Day 1	Day 2	Day 3	Change
Subfloor (N wall cavity)	Subfloor OSB	24.1%	18.4%	12.2%	-11.9%
Drywall base - N wall	Drywall	19.6%	14.1%	9.3%	-10.3%
Drywall base - E wall	Drywall	22.3%	16.8%	11.0%	-11.3%
Subfloor center	Subfloor OSB	20.7%	15.2%	9.8%	-10.9%

Day 1 - Day 3 | 12 readings | 4 points

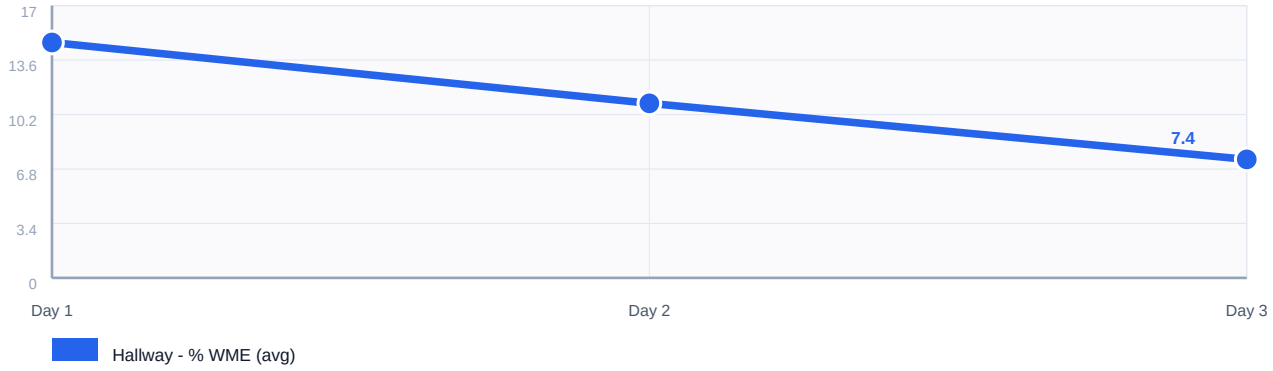
Hallway

Location	Material	Day 1	Day 2	Day 3	Change
Flooring - N section	Hardwood	17.2%	12.6%	8.4%	-8.8%
Flooring - S section	Hardwood	14.8%	10.9%	7.2%	-7.6%
Drywall base - W wall	Drywall	11.3%	8.7%	6.1%	-5.2%
Subfloor under hardwood	Subfloor OSB	15.6%	11.4%	7.8%	-7.8%

Day 1 - Day 3 | 12 readings | 4 points

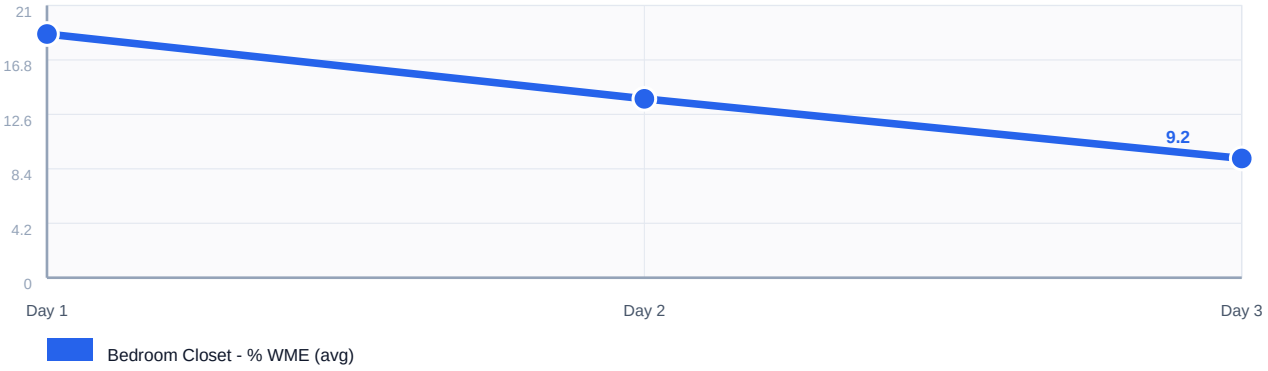
Bedroom Closet

Location	Material	Day 1	Day 2	Day 3	Change
Subfloor - cavity access	Subfloor OSB	21.4%	16.0%	10.5%	-10.9%
Drywall - common wall	Drywall	18.9%	13.7%	9.1%	-9.8%
Drywall - closet W	Drywall	16.2%	11.8%	7.9%	-8.3%

Day 1 - Day 3 | 9 readings | 3 points
